Appendix E

Characteristics and Earthquake Performance of RVS Building Types

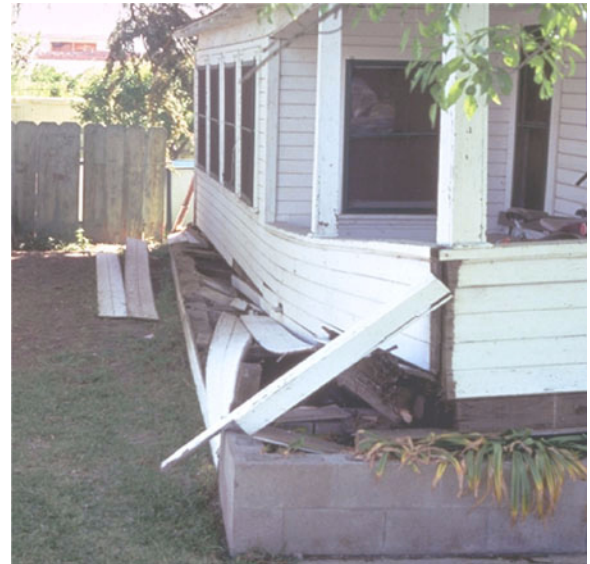
Figure E-7 House off its foundation, 1983 Coalinga earthquake.

type of damage helps dissipate the earthquake-induced energy of the shaking house. The most common type of structural damage in older buildings results from a lack of adequate connection between the house and the foundation. Houses can slide off their foundations if they are not properly bolted to the foundations. This movement (see Figure E-7) results in major damage to the building as well as to plumbing and electrical connections. Overturning of
